# JOHNSVILLE

## STYLE BOOK FOR AN HISTORIC MINING TOWN

Plumas County, California  
1972

# JOHNSVILLE STYLE BOOK

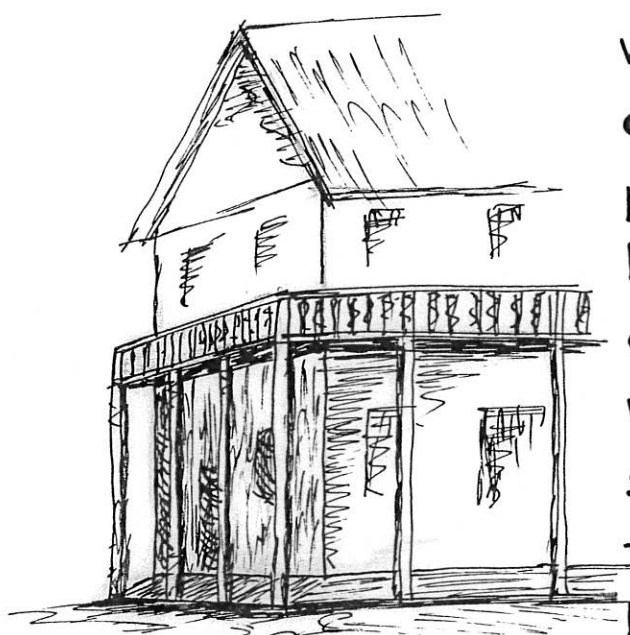
Second Story Porch

Second story porches, with simple or beveled 2x2 rails and posts were common. Not only did such appurtenances provide shelter from sun, rain and snow for the first floor, but they also served a very important

function as the entry way to buildings during the heavy winter snows (12-20 ft.)

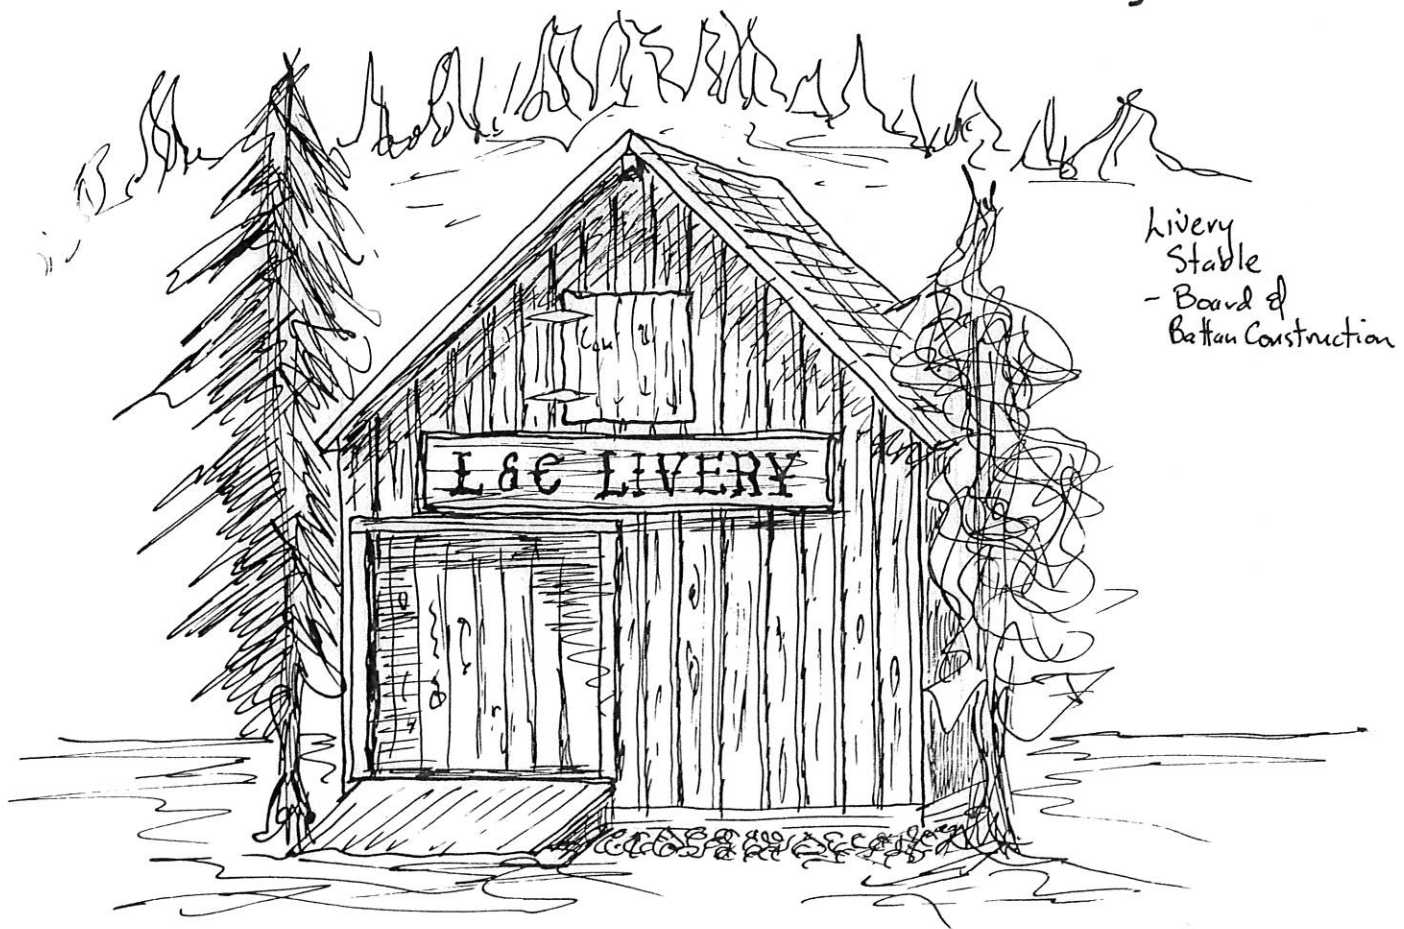
Livery  
Stable  
- Board of  
Battau Construction

For main buildings and frontages, either V-rustic or cove, cut lumber was used. Unfinished board and batten siding was also common; although this material was apparently reserved for accessory buildings, shops, and the rear portion of some main structures.

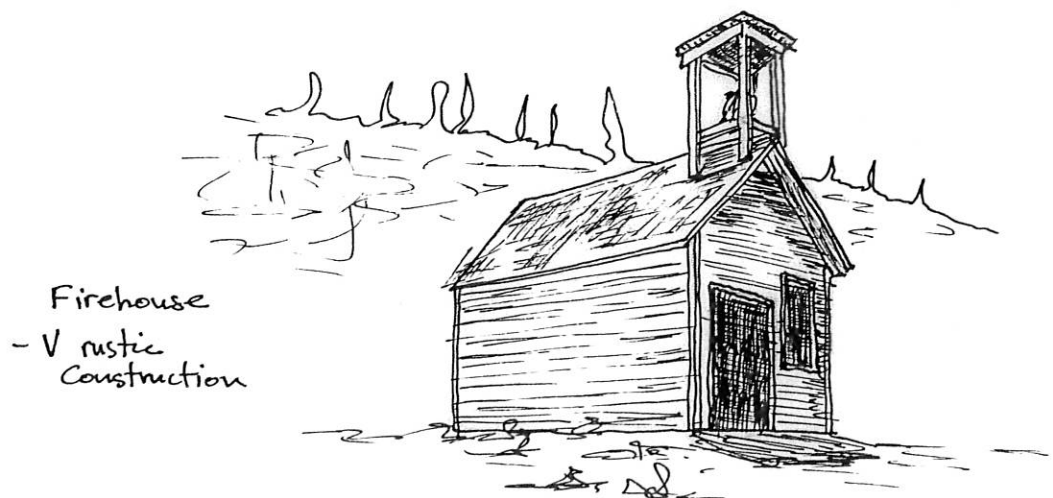
In addition to the basic materials noted above, others may be used where they fit into the gold rush architectural pattern. For example, long shingles with 10" or greater weather were common in many outlying areas; and several examples are still visible in the La Porte area. New reverse-cove plywood simulates, to a degree, the classic board and batten siding; and such wood, rough sawn, may be considered a suitable alternate to the basic styles enumerated previously.
