RECORD OF SURVEY  
for

Tom Bengard

A portion of Sections 1, 2, 11 and 12

T. 24 N., R. 9 E., M.D.M.

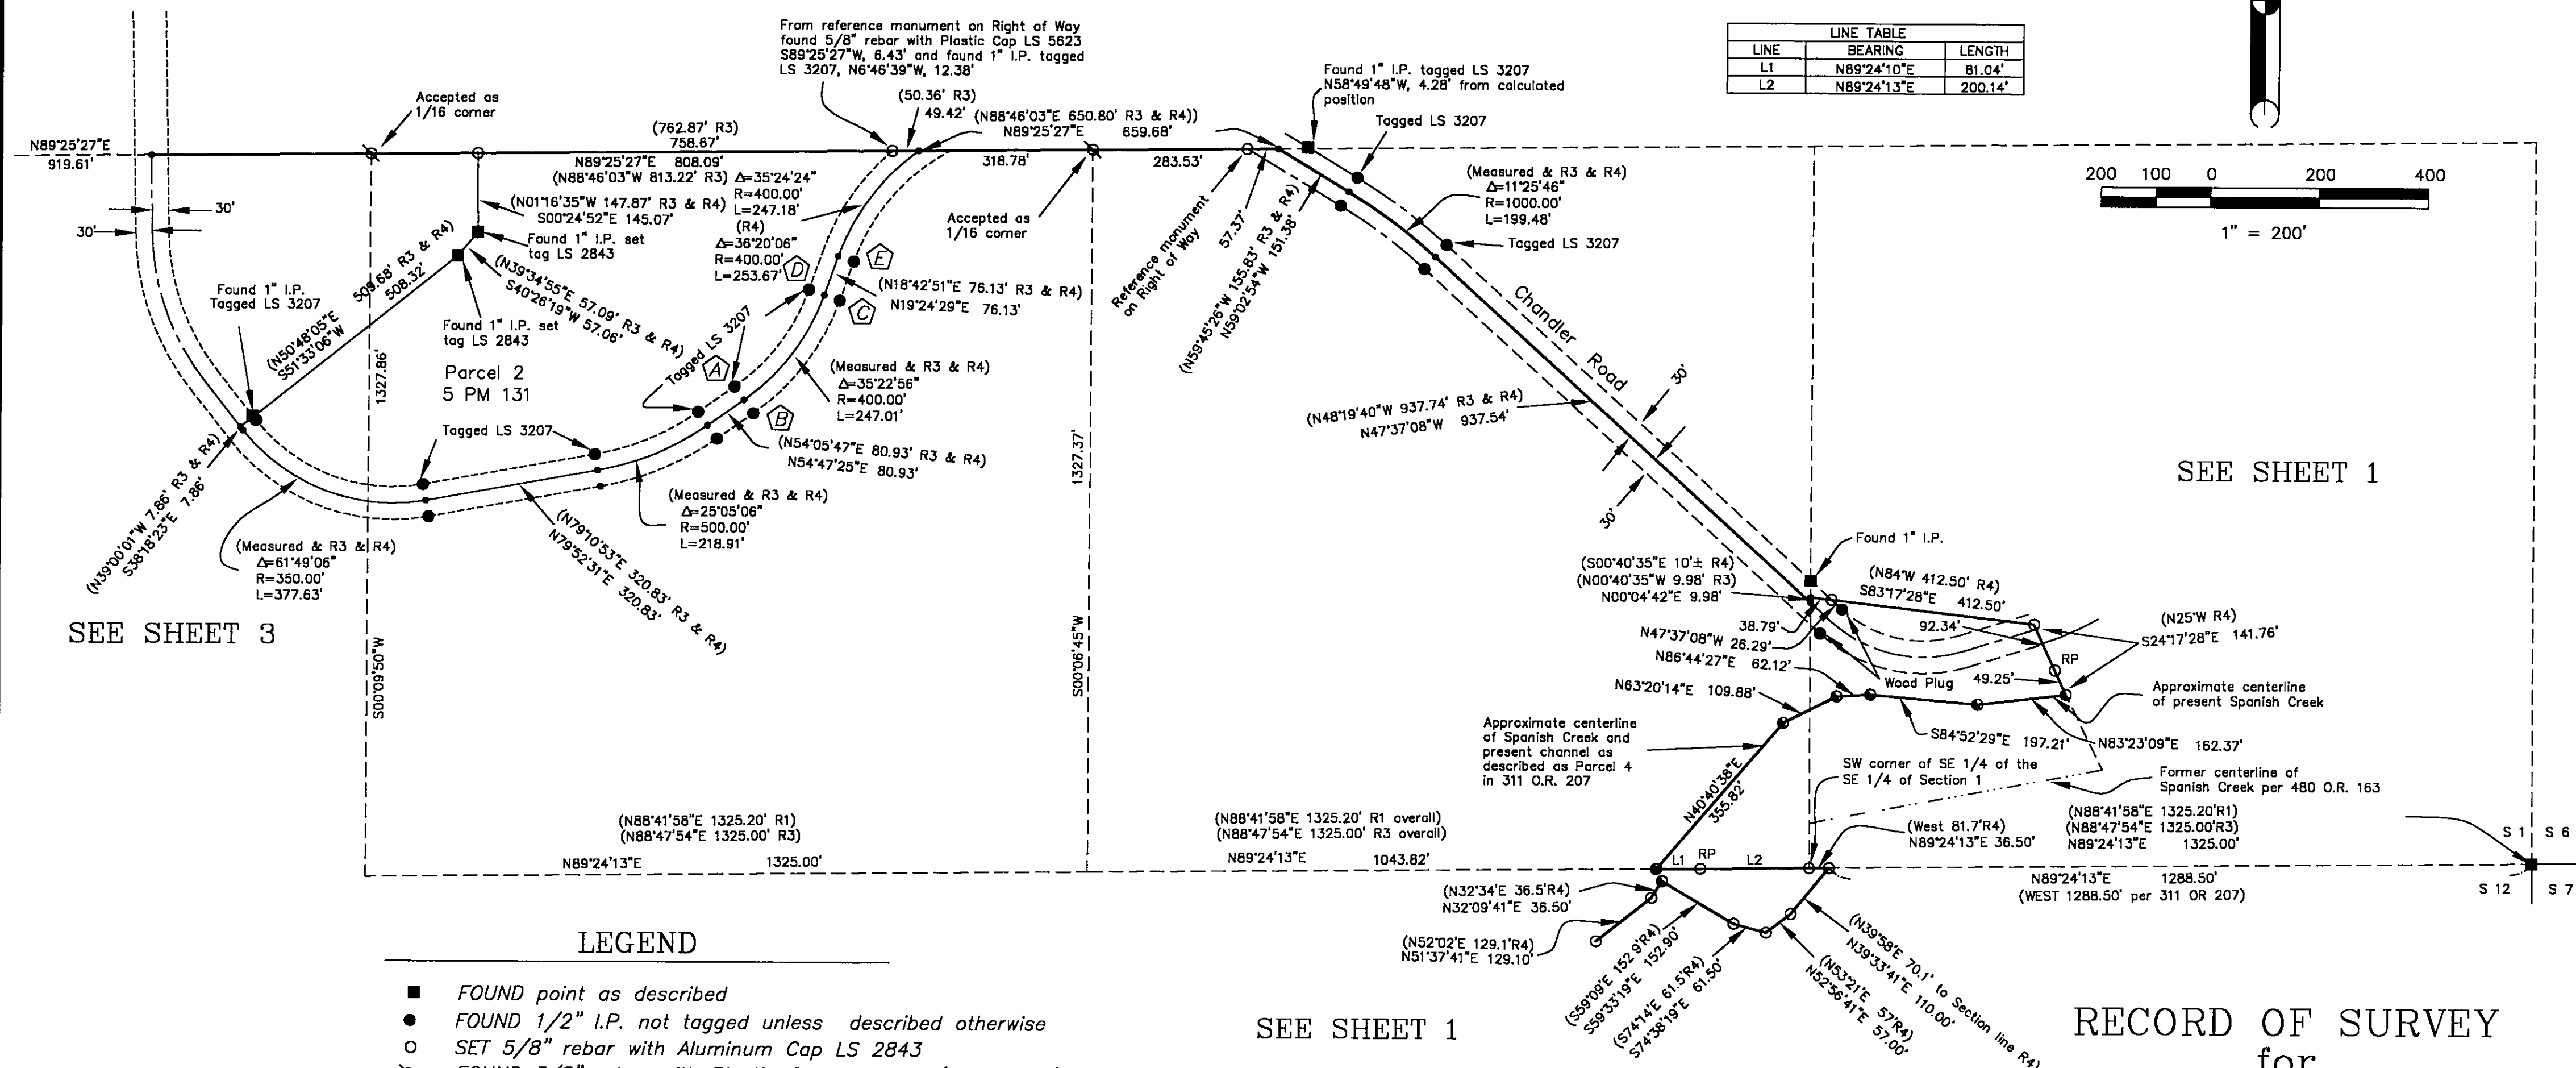
SHEET 2 OF 4

Note: Found point information

- A. Found S65°28'57"W, 0.73' from calculated point
- B. Found S61°10'57"W, 0.85' from calculated point
- C. Found N39°40'57"W, 8.03' from calculated point
- D. Found N14°04'32W, 11.98' from calculated point
- E. Found 26°30'20"E, 3.81' from calculated point
