### RECORD OF SURVEY

SECTIONS 26 & 27, T23N R11E, MDM  
PLUMAS COUNTY, CALIFORNIA

FOR  
U.S.D.A. PLUMAS NATIONAL FOREST  
159 LAWRENCE ST  
QUINCY, CA. 95971

SHEET 5 OF 11

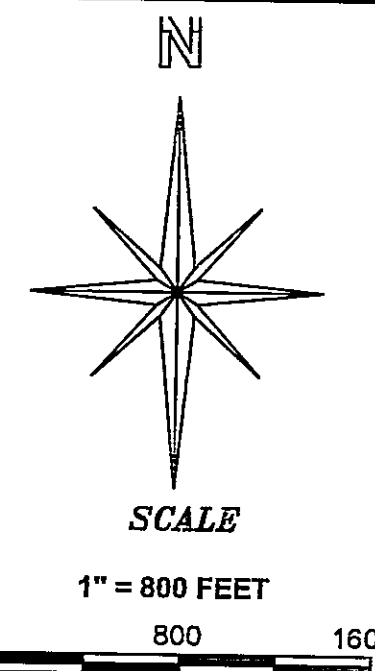
RECORD: 48"X3"X3" PINE POST IN MOS (George Sandow July 1880)  
 FWBS: 4"DOGWOOD N27E 27 LKS  
 FWBS: 22" FIR S59W 14 LKS  
 FOUND: M.O.S. (ACCEPTED MOS AS CORNER) (4RS32)  
 SET: STANDARD USFS MONUMENT IN MOS  
 FWB: 21" FIR SCRIBED 1/4 S22 BT N42°56'W 17.5'  
 FWB: 30" FIR SCRIBED 1/4 S23 BT N58°53'E 42.5'

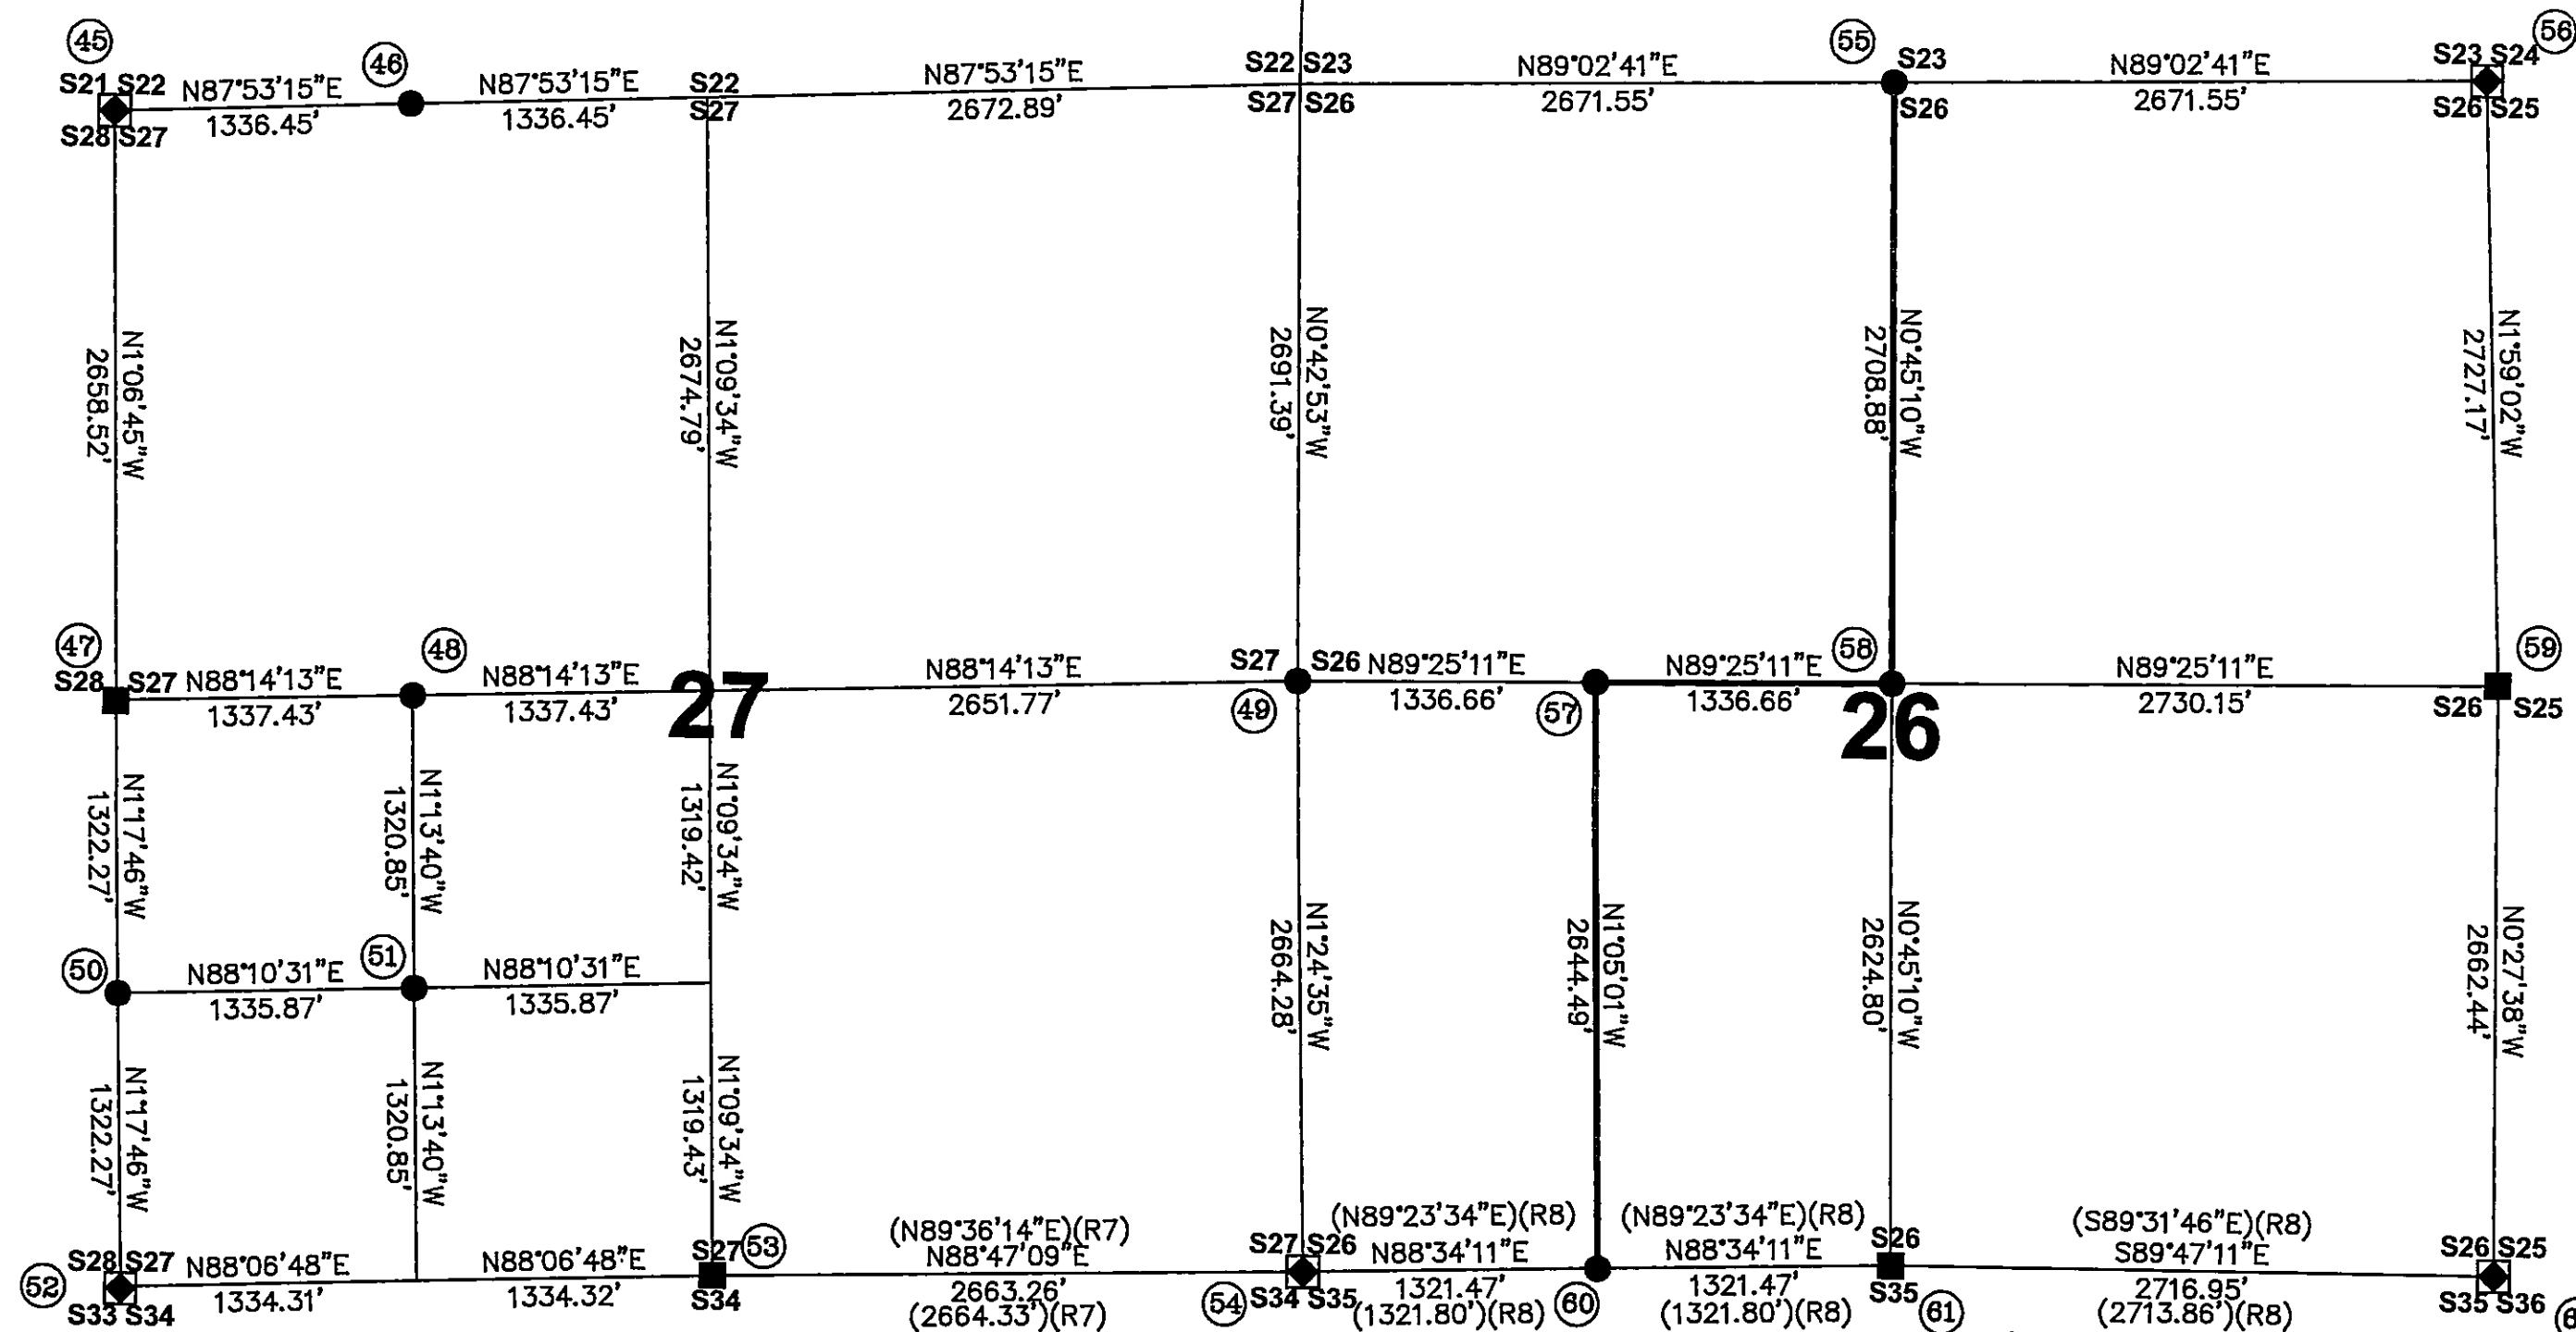
MEASURED BEARINGS AND DISTANCES ARE GRID  
 BASED ON THE CALIFORNIA COORDINATE SYSTEM OF 1983  
 (CCS83), ZONE 1.

θ AT THE SE CORNER OF SECTION 11 IS 0°50'54"  
 TO GET TO TRUE NORTH ROTATE TO RIGHT 0°50'54"  
 MULTIPLY GRID DISTANCES BY .9998356477 TO GET  
 GROUND DISTANCES.

- ◆ FOUND BLM CORNER
- └ CALCULATED CORNER
- ⑩ CORNER NOTE
- SET STANDARD U.S. FOREST  
SERVICE DRIVE-IN MONUMENT  
(BEARING TREES AS NOTED)
- PROPERTY BOUNDARY MARKED  
AND POSTED
- FD CORNER AS NOTED
- (R3) 4RS32
- (R7) 4RS82
- (R8) 4RS17
